**Corrosion of Galvanized  
Fasteners used in Cold-  
Formed Steel Framing**

**RESEARCH REPORT RP04-4**

# **Corrosion of Galvanized Fasteners used in Cold-Formed Steel Framing**

## **FINAL REPORT**

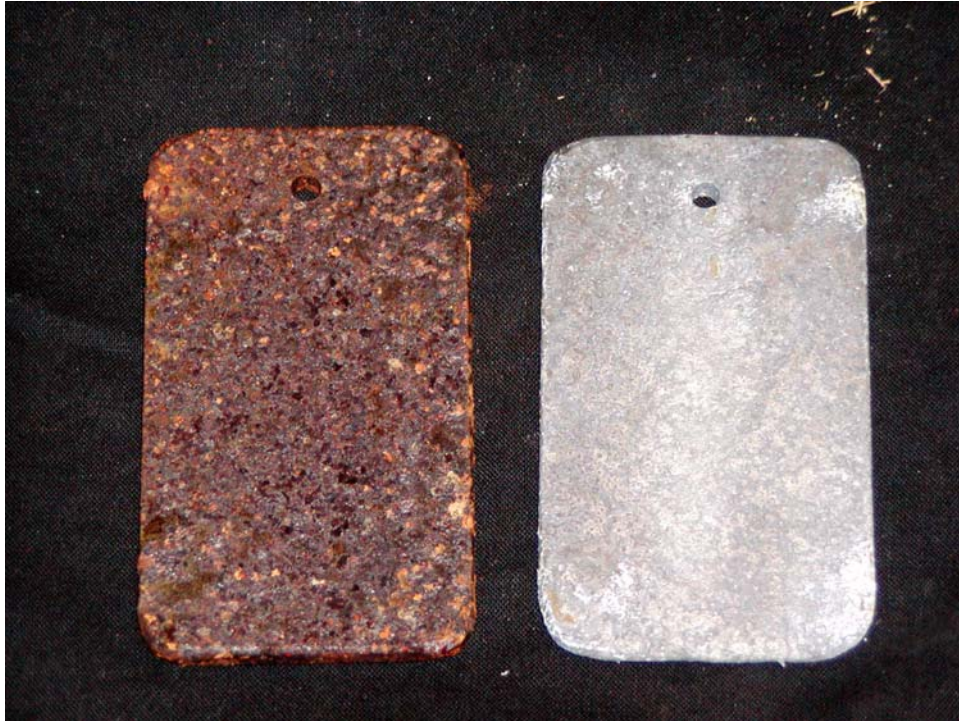
**Figure 5.12: Steel and zinc coupons after 3186 cycles in the corrosion chamber.**

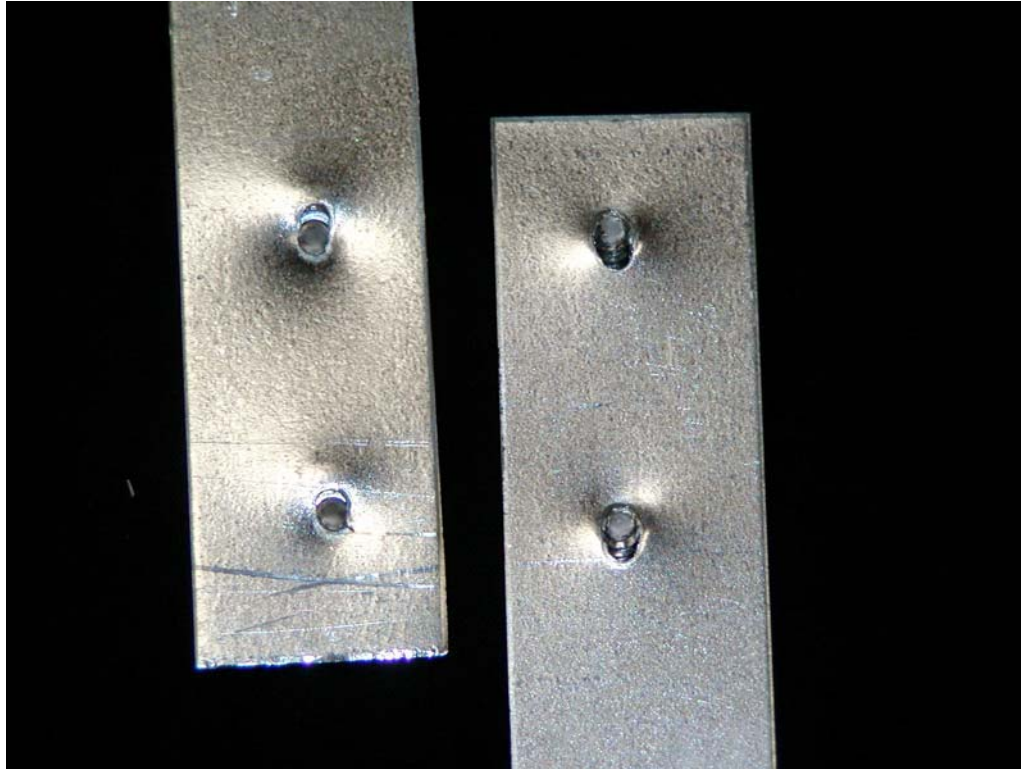
**Figure 6.2: Typical control test specimen after failure.**

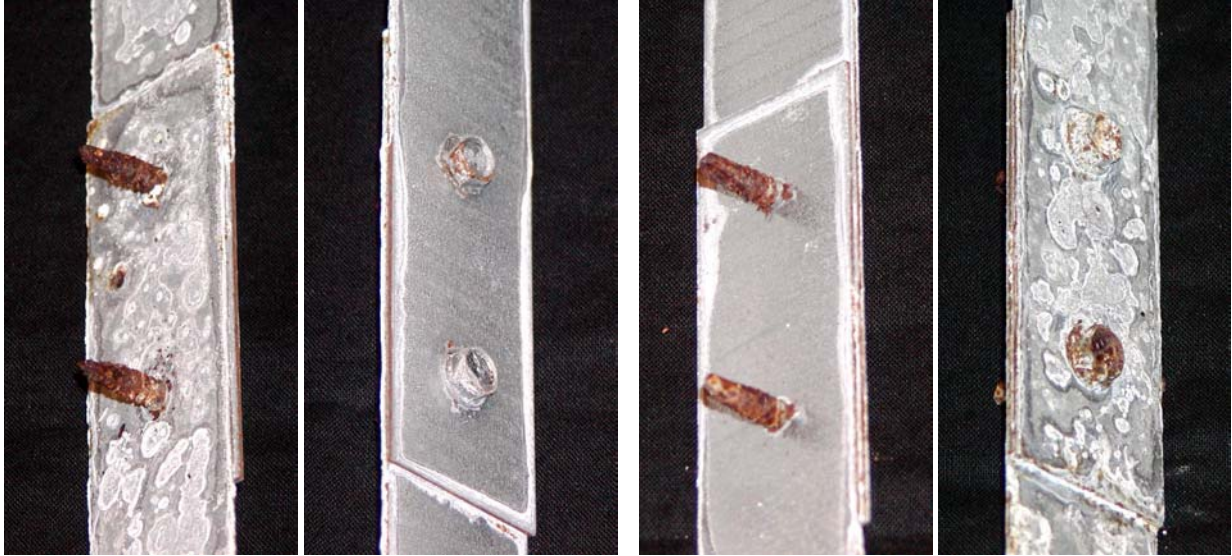
After 2772 cycles in the corrosion chamber, the galvanized screws showed significant surface corrosion (Figure 6.32). Nevertheless, the average connection strength had not decreased, regardless of whether the threads were oriented up or down in the corrosion chamber (Figure 6.35). However, the average specimen elongation at the peak load had decreased to around 80% of that for the control specimen (Figure 6.36). This decrease was larger for the connections stored with threads up. It appears that the connection ductility is affected by this level of corrosion, though the strength is not. Figure 6.37 to Figure 6.40 show microscopic images of the screw threads for control and 1537 cycle test specimens before and after testing. Although the surface corrosion appears significant, it has not yet penetrated the shaft of the screw, and hence has not affected the screw failure strength (Figure 6.40).

Figure 6.32: Test connections after 2772 cycles – Threads up (left) and down (right)

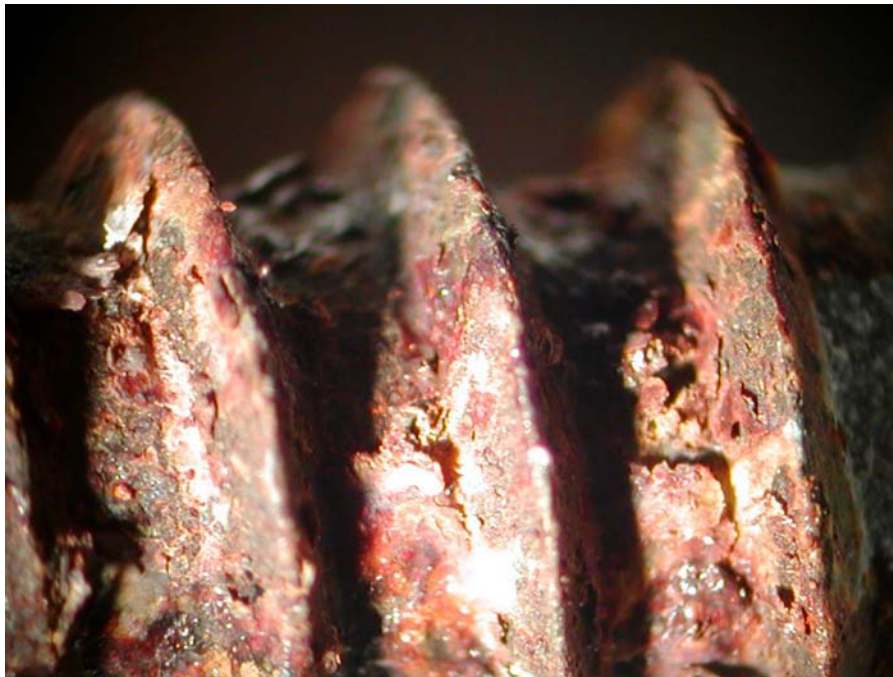
**Figure 6.38: Screw threads after 1537 cycles in the corrosion chamber.**

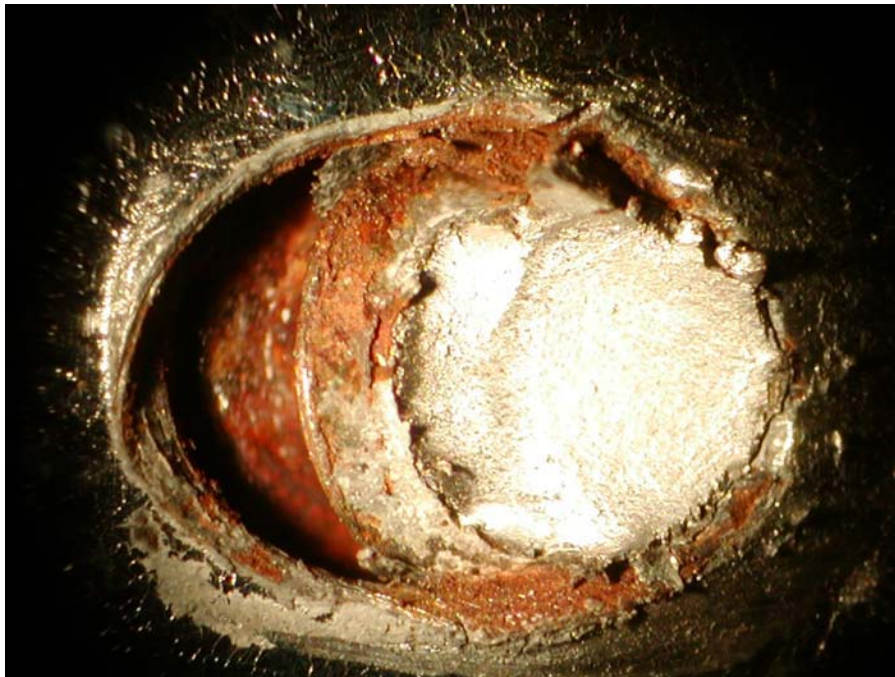
**Figure 6.40: Close-up of screw threads after failure of 1537 cycle specimen.**

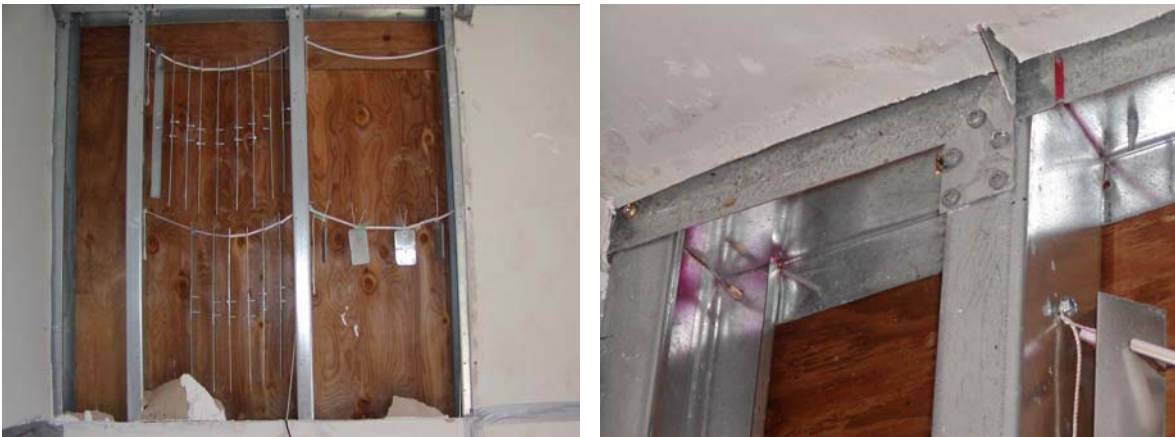
As seen in Figure 7.1, there were no signs of corrosion on the CFS framing or fasteners in the enclosed wall framing for these three sites.

Figure 7.1: Interior wall framing and fasteners at Iroquois Coastal site after 20 months exposure

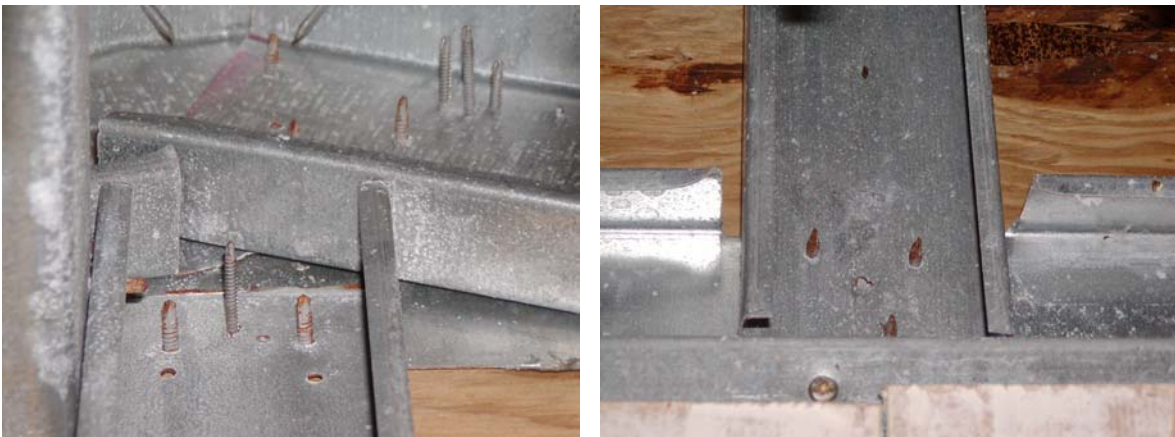
Initiation of corrosion was evident at the cut edges of the CFS framing and on some of the fasteners in the vented attics of the two Iroquois sites as shown in Figure 7.2. The fasteners in the vented attic at the Wheeler site showed no corrosion as seen in Figure 7.3.

Figure 7.2: Attic framing at Iroquois Coastal site after 20 months exposure.

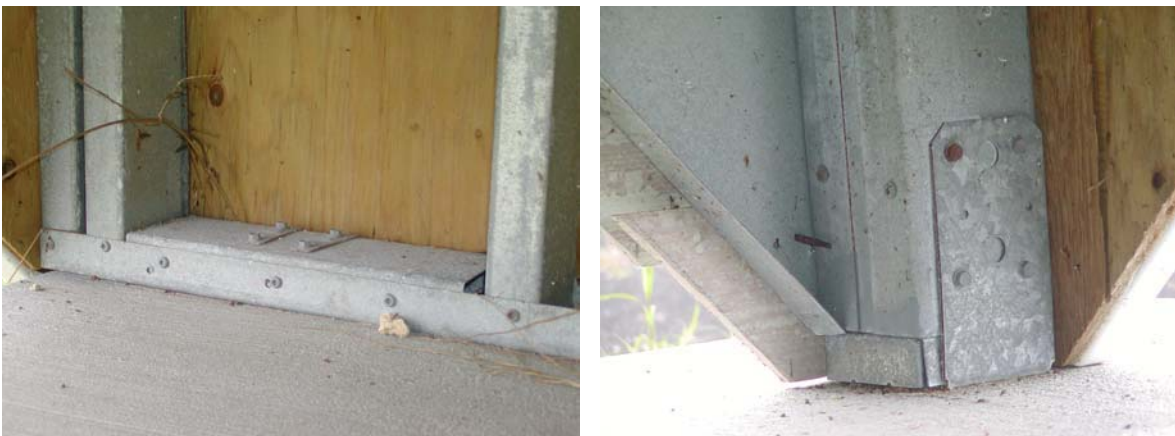
**Figure 7.12: Crawl space cripple wall and post at MCBH Inland after 28 months exposure.**

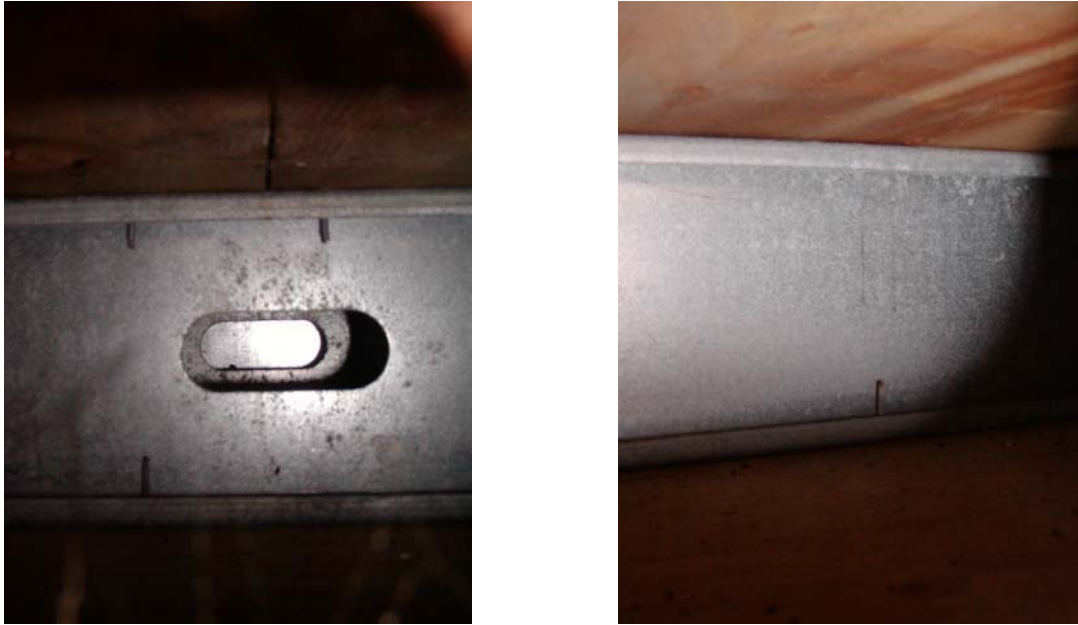
**Figure 7.35: Crawl space covered floor joists, MCBH Coastal after 16 months.**
