**Experimental Study on
System Reliability of
Cold-Formed Steel Roof
Trusses**

Report RP17-1

Report No. UNT-GP6469

A Research Report Submitted to the American Iron and Steel Institute
January 24, 2017

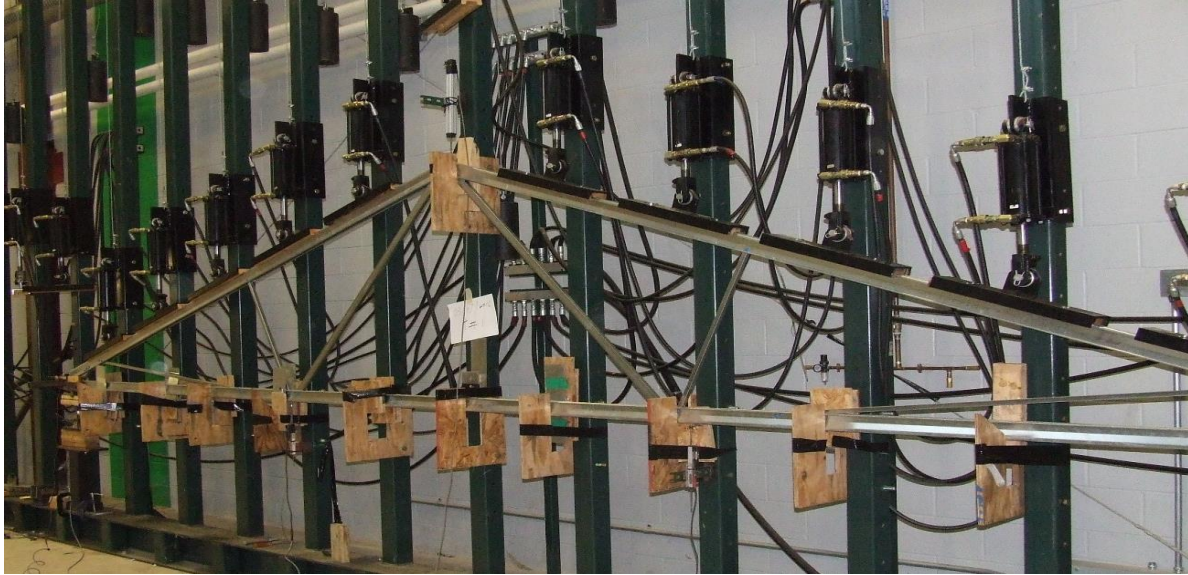
Figure 3: TrusSteel Test Setup

A series of full-scale static tests on CFS roof trusses with a unique experimental setup were conducted in the University of North Texas’ structural testing laboratory. The test specimens were carefully monitored and three main failure modes were observed: buckling of the top chord, buckling of the truss webs, and any connection failures. Table 1 lists the testing matrix that was used to test the two different truss profiles in this research and Figure 3 is a photograph taken during our first trial test for the single truss tests.

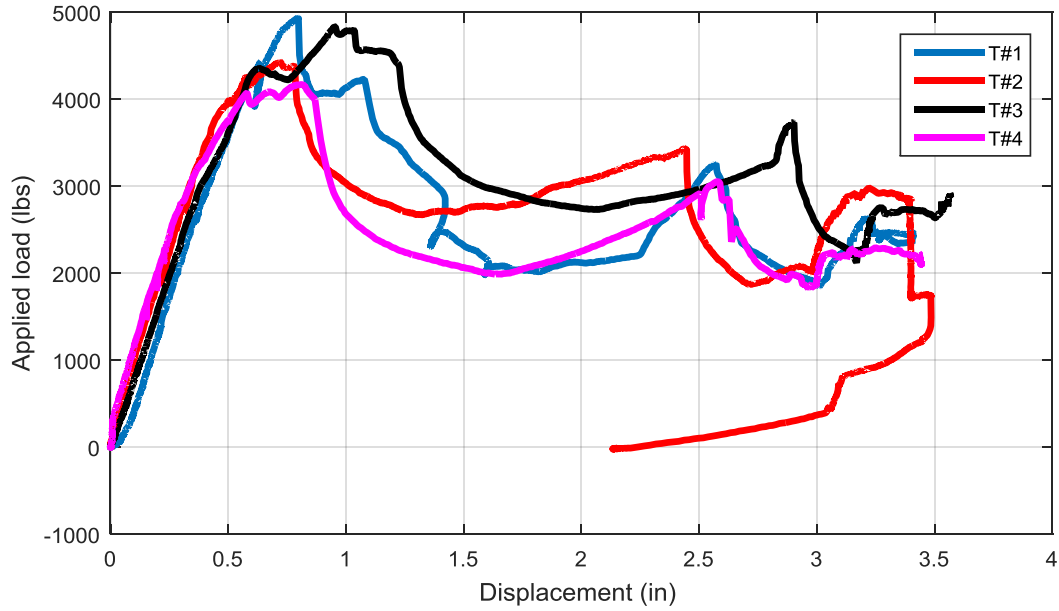
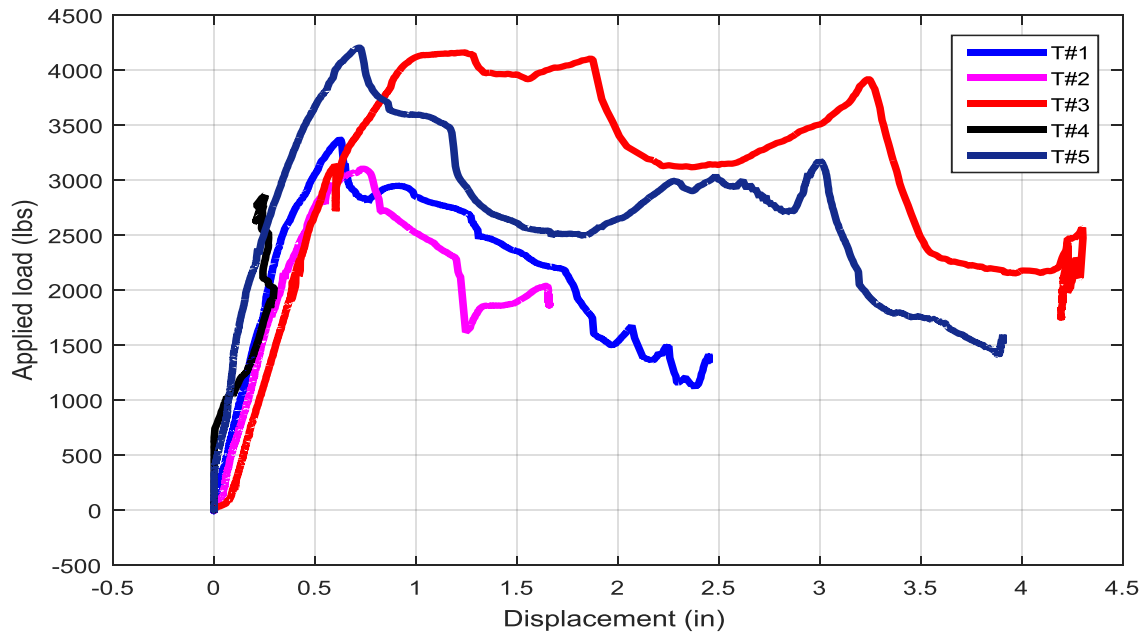
Figures 10 and 11 illustrate the different failure modes recorded by sensors located at the peak of the TrusSteel truss's top chord and at the midpoint of the Aegis truss's bottom chord, respectively, for all single truss tests. Although these displacement sensors are recording data at different locations, we expected the data received from each to be very similar due to them being located the same distance along the length of the truss.

Figure 10: TrusSteel Testing summary of midpoint displacement sensor at top chord of trusses for all tests

Figure 11: Aegis Testing summary of midpoint displacement sensor at bottom chord of trusses for all tests
