**Corrosion of Galvanized  
Fasteners used in Cold-  
Formed Steel Framing**

**RESEARCH REPORT RP04-4**

# **Corrosion of Galvanized Fasteners used in Cold-Formed Steel Framing**

## **FINAL REPORT**

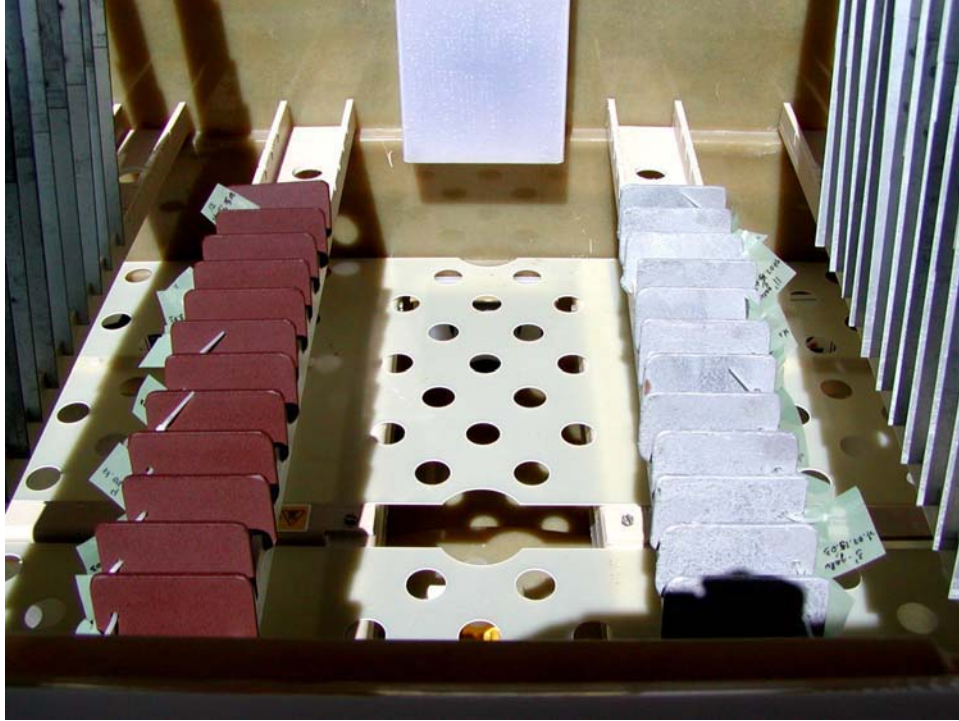
**Figure 5.10: Steel and zinc coupons after 5 days in the corrosion chamber (160 cycles)**

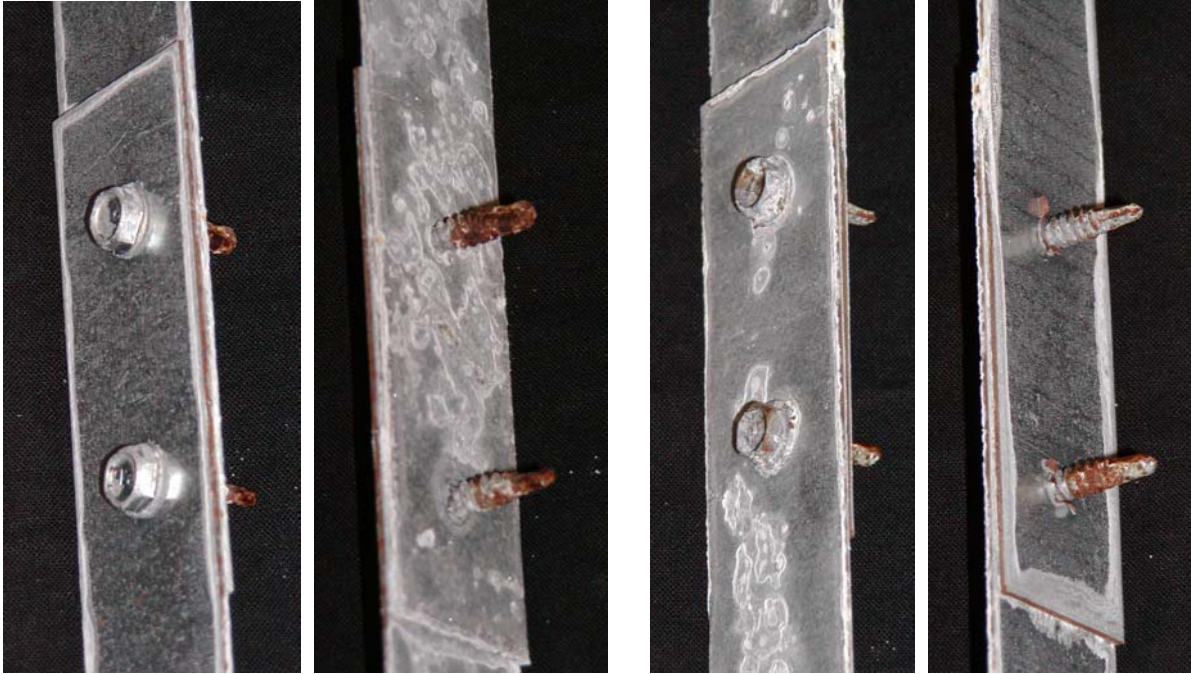
Figure 6.20: Test connections after 1309 cycles – Threads up (left) and down (right)

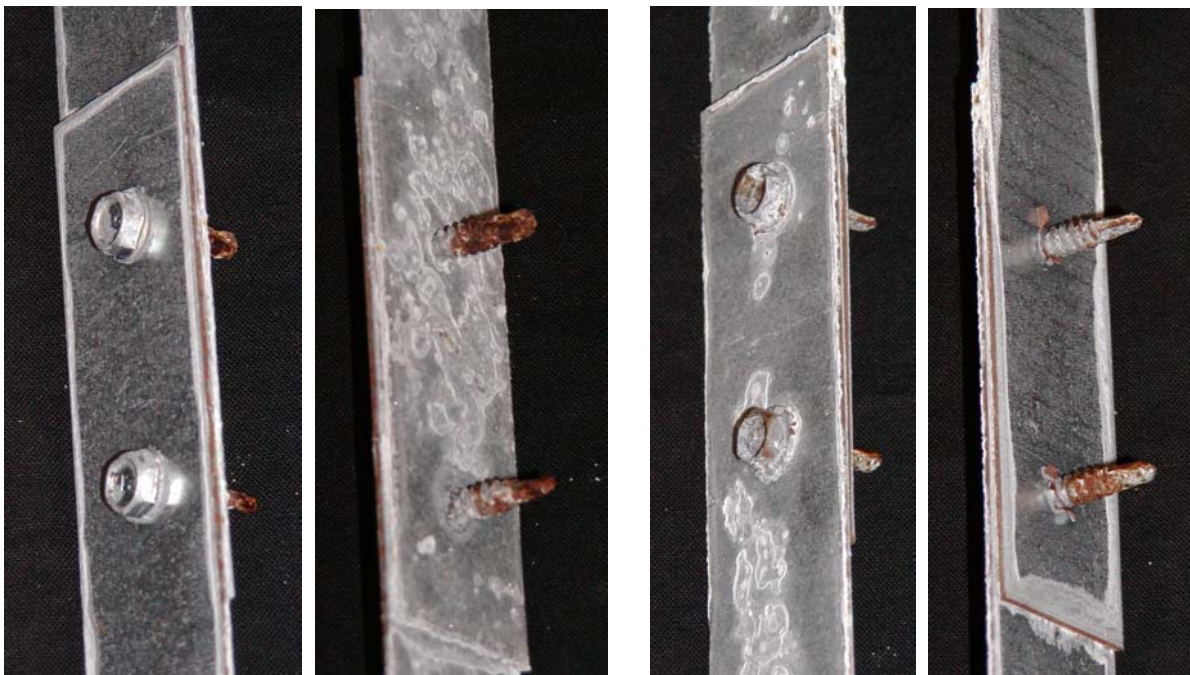
Figure 6.23: Test connections after 1537 cycles – Threads up (left) and down (right)

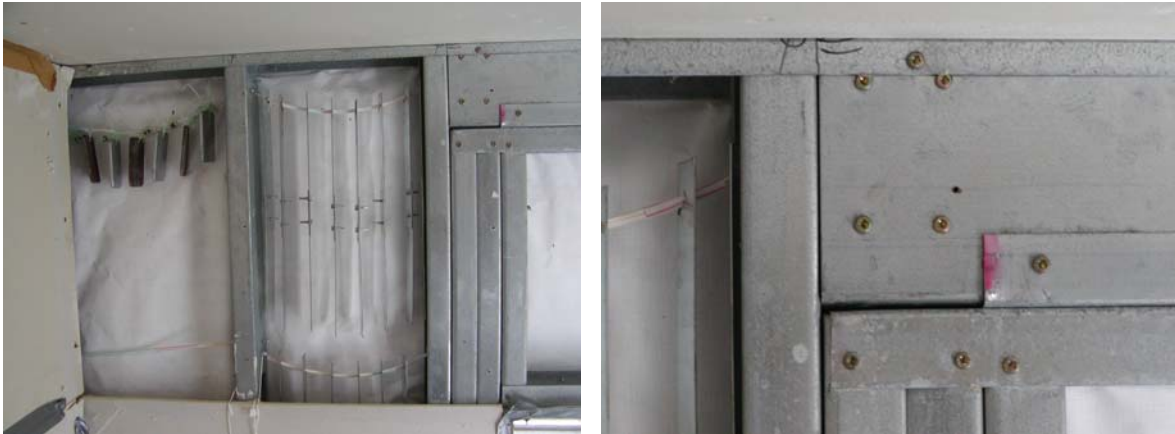
After 28 months of exposure, no evidence of corrosion was noted on the framing members or fasteners in the wall framing with vapor barrier (Figure 7.6).

**Figure 7.6: Wall framing with vapor barrier at MCBH Inland after 28 months exposure.**

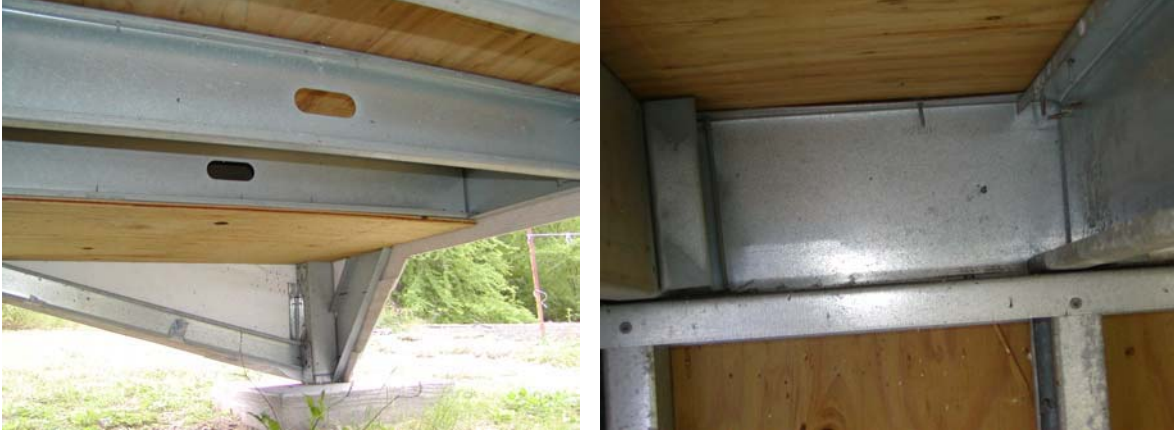
Figure 7.13 and Figure 7.14 show the exposed floor joist framing in the crawl space of the MCBH Inland enclosure. After 16 months, there was some tarnishing of the joists, but no evidence of ferrous oxide on the fasteners. By 28 months, the joists were fully tarnished and minor ferrous oxide was noted on some of the fastener threads. For the floor joists enclosed by plywood sheathing, there were no signs of corrosion after 28 months of exposure (Figure 7.15).

**Figure 7.13: Crawl space floor joists at MCBH Inland after 16 months exposure.**

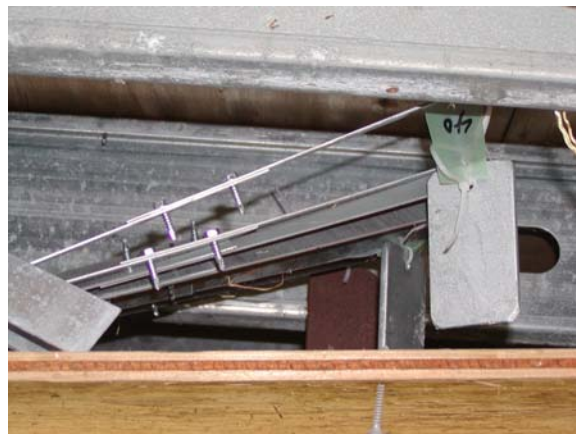
**Figure 7.15: Floor joist with plywood sheathing after 28 months exposure.**

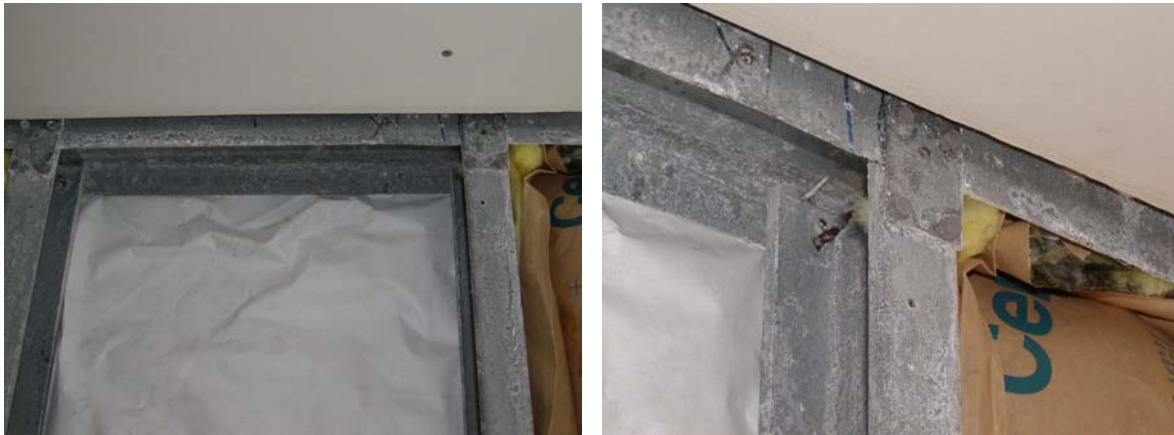
After 16 months of exposure, there was evidence of corrosion of both the CFS members and framing fasteners at the top plate of the wall with vapor barrier (Figure 7.16). This corrosion appeared limited to the top plate and top section of the studs. There was considerably less corrosion further down the stud. This condition worsened after 21 months (Figure 7.17) and 28 months (Figure 7.18), by which time most of the framing fasteners in the top plate connections showed signs of ferrous oxide. There was still very little sign of corrosion on the studs at mid-height of the wall. It appeared that humid, chloride rich air was passing from the vented attic to the top plate connections, resulting in the localized corrosion. No seal had been provided between the top plate and the attic space. For the first 16 months, the interior drywall had also not been taped, so humidity could also have entered the wall cavity through the drywall joints. It was noted that the ETF pins used to secure the Hardie Board had less ferrous oxide corrosion than the framing screws (Figure 7.16).

**Figure 7.16: Wall framing with lap siding and vapor barrier, MCBH Coastal after 16 months.**

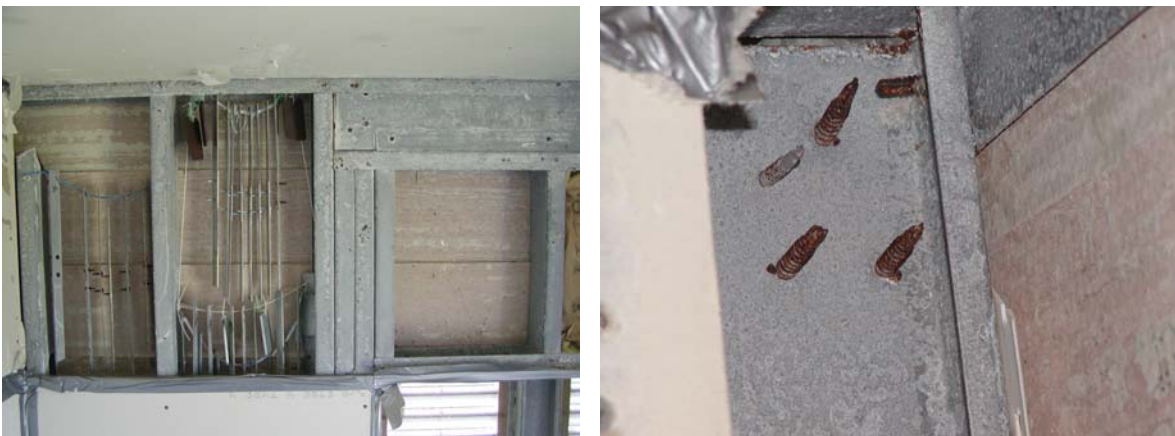
**Figure 7.21: Wall framing with lap siding without vapor barrier, MCBH Coastal after 28 months.**

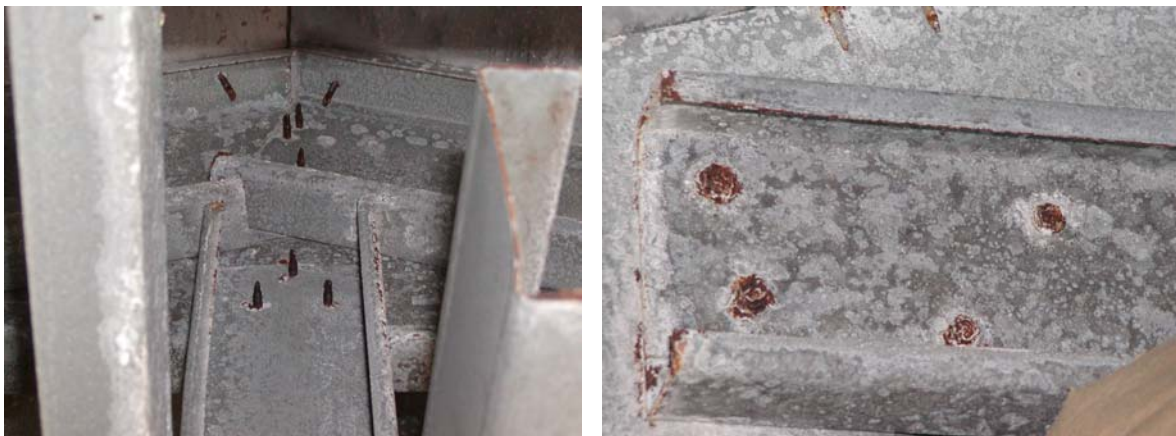
After 16 months there was already significant ferrous oxide on virtually all of the fasteners in the vented attic (Figure 7.25). This condition worsened at 21 months (Figure 7.26) and 28 months (Figure 7.27), by which time there was also significant ferrous oxide at cut ends of the CFS framing members (Figure 7.27).

Figure 7.27: Vented attic framing at MCBH Coastal after 28 months.

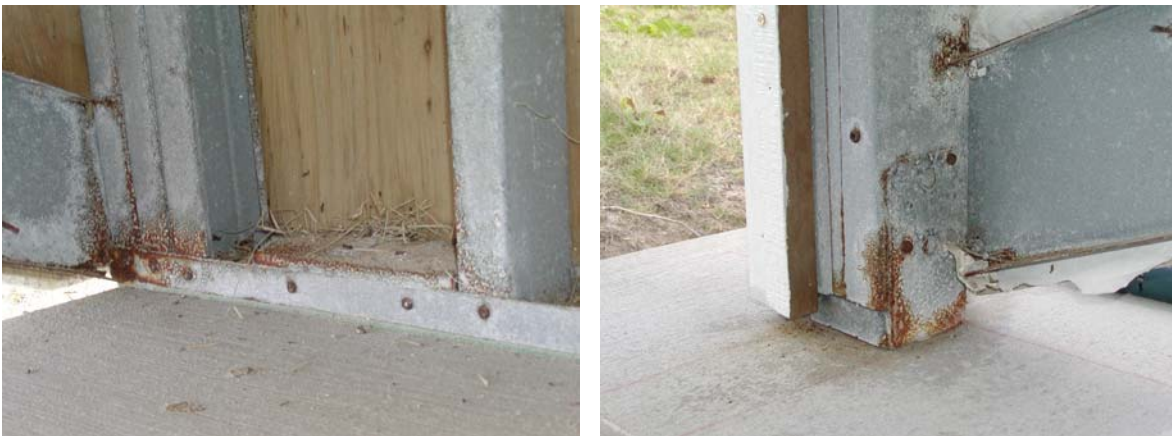
Figure 7.28, Figure 7.29, Figure 7.30 and Figure 7.31 show a progression of the corrosion on the cripple wall and post supports in the crawl space of the MCBH Coastal enclosure. After 5 months there were signs of tarnishing of the zinc galvanizing, and ferrous oxide on some of the fastener heads or threads, and cut ends of the CFS members (Figure 7.28). By 16 months, the zinc coating on portions of the CFS framing had corroded completely and ferrous oxide was forming on end regions of the CFS members and galvanized anchor hardware. There was also significant ferrous oxide on the exposed fastener heads (Figure 7.29). At the 21 month inspection it was clear that this corrosion had progressed rapidly (Figure 7.30) and after 28 months there was clear indication that the corrosion had compromised the integrity of the CFS studs, post and post base hardware (Figure 7.31). The corrosion appeared to concentrate in regions exposed directly to through flow of chloride laden air from the nearby coastline.

**Figure 7.29: Crawl space cripple wall and post, MCBH Coastal after 16 months.**

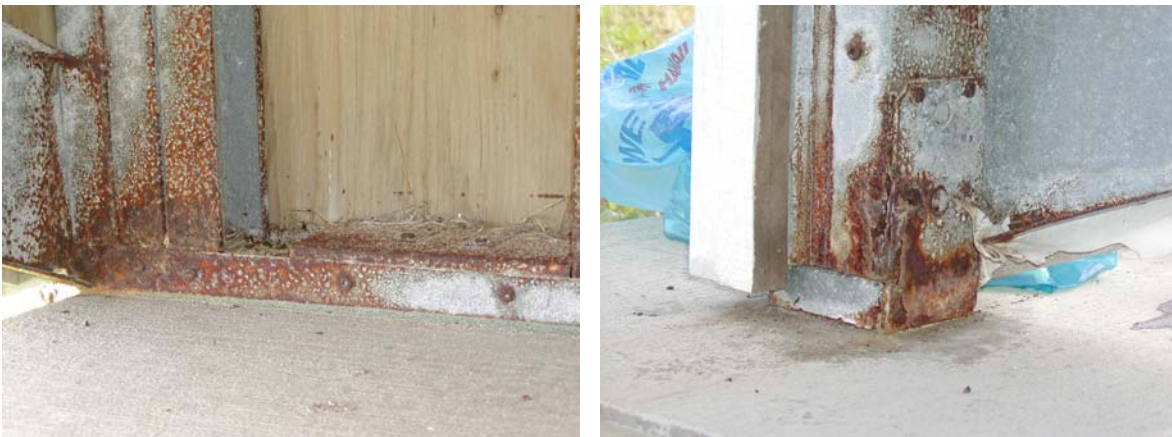
**Figure 7.31: Crawl space cripple wall and post, MCBH Coastal after 28 months.**

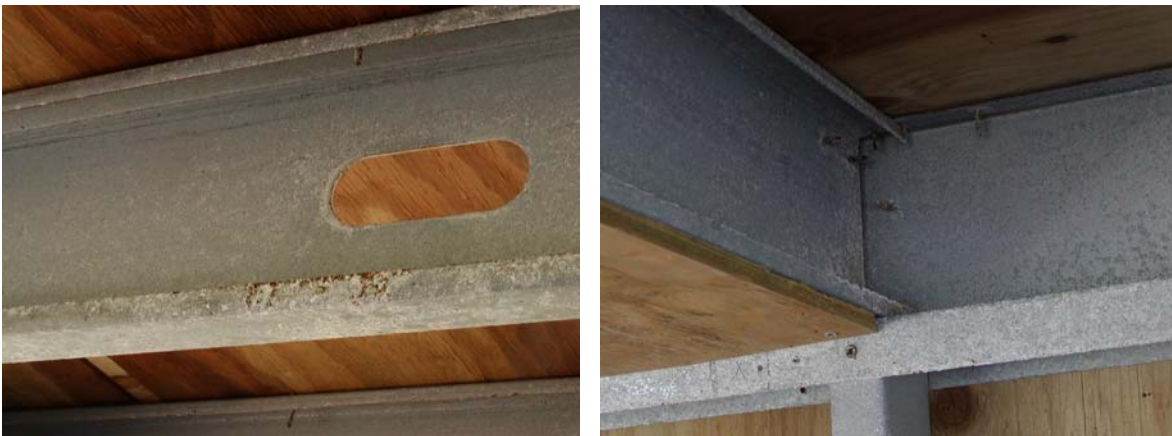
Figure 7.32 through Figure 7.38 show the exposed floor joist framing in the crawl space of the MCBH Coastal enclosure. After 5 months, the surface of the joists was tarnished and there was evidence of ferrous oxide on cut edges and some of the exposed fasteners (Figure 7.32). After 10 months exposure, this corrosion had progressed significantly with considerable ferrous oxide at the joist bottom flange and at cut ends and punchouts. There were also signs of ferrous oxide on most of the exposed fasteners (Figure 7.33).

**Figure 7.32: Crawl space exposed floor joists, MCBH Coastal after 5 months.**

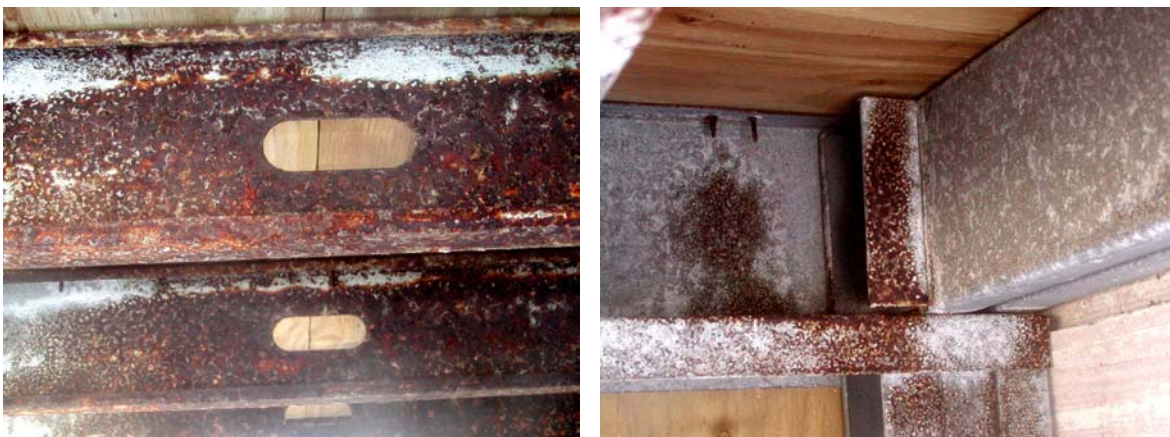
After 21 months, corrosion of the exposed floor joists had progressed to the point where it would be described as severe (Figure 7.36). Large areas of the zinc galvanizing have corroded completely, allowing significant corrosion of the underling steel sheet. Exposed fasteners in the joist end connections and between the plywood flooring and the joist top flange also showed significant corrosion. However, the joists covered by plywood sheathing were still in the original “like new” condition (Figure 7.37). The only signs of corrosion on these enclosed floor joists were at the end connections where there was corrosion on the member cut ends and the connection fasteners. This corrosion was attributed to leaking of exterior air between the end of the plywood sheathing and the cripple wall top plate (Figure 7.37). This edge of the plywood sheathing simply butted against the edge of the top plate, and had not been sealed.

**Figure 7.36: Crawl space exposed floor joists, MCBH Coastal after 21 months.**

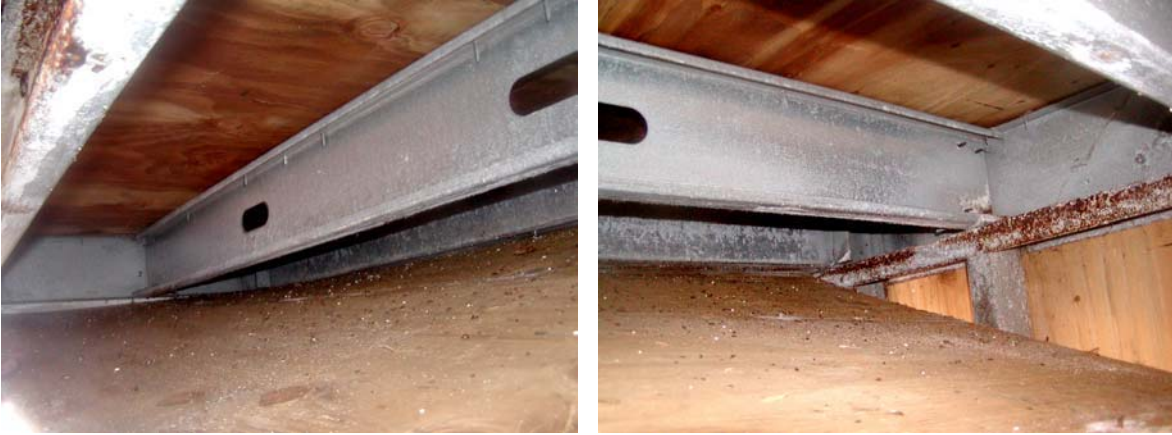
**Figure 7.37: Crawl space covered floor joists, MCBH Coastal after 21 months.**
