**Corrosion of Galvanized  
Fasteners used in Cold-  
Formed Steel Framing**

**RESEARCH REPORT RP04-4**

# **Corrosion of Galvanized Fasteners used in Cold-Formed Steel Framing**

## **FINAL REPORT**

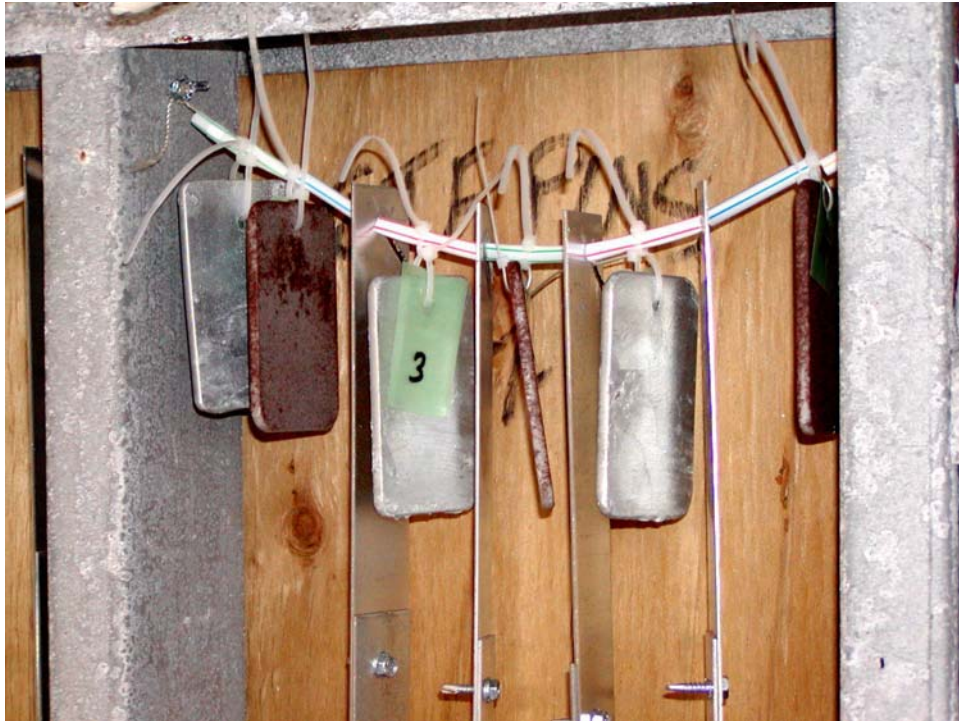
**Figure 5.11: Steel and zinc coupons along with connection specimens in wall cavity.**

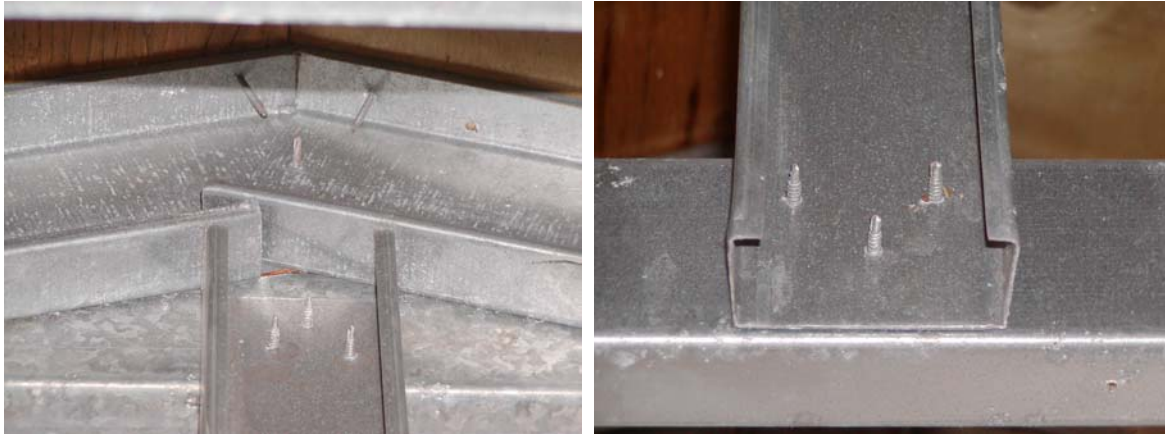
**Figure 7.3: Attic framing at Wheeler site after 20 months exposure.**

Initiation of corrosion was evident at the cut edges of the CFS framing and on some of the fasteners in the vented attics of the two Iroquois sites as shown in Figure 7.2. The fasteners in the vented attic at the Wheeler site showed no corrosion as seen in Figure 7.3.

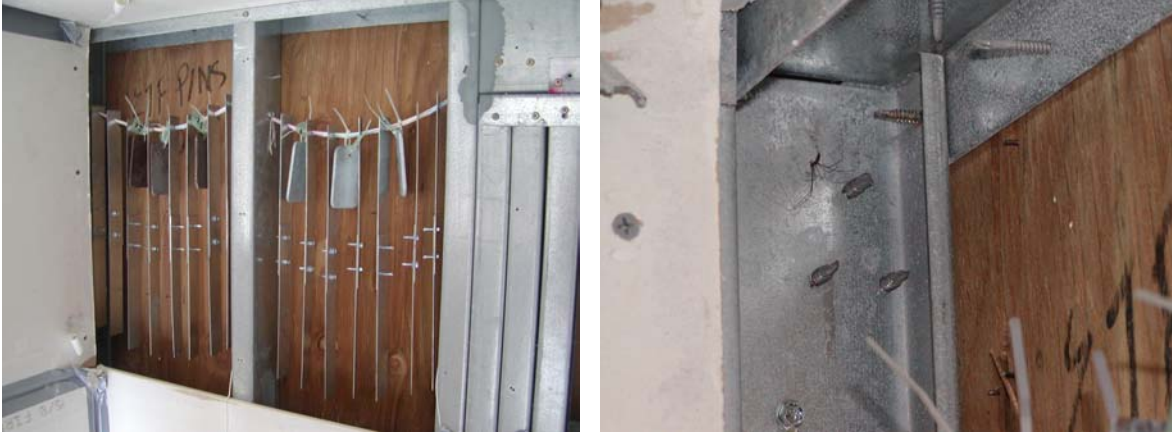
After 28 months of exposure, no evidence of corrosion was noted on the framing members or fasteners in the wall framing with plywood sheathing and no vapor barrier (Figure 7.8).

Figure 7.8: Wall framing with plywood sheathing at MCBH Inland after 28 months.

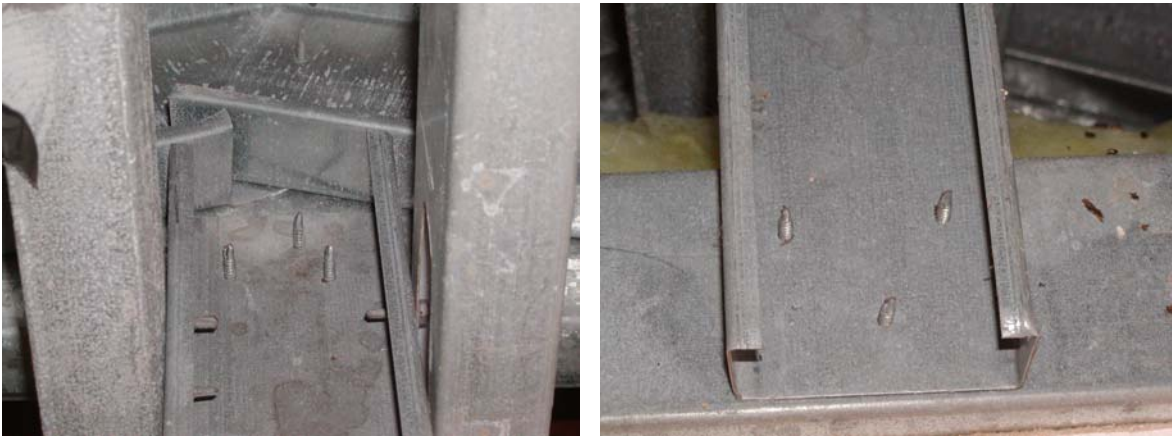
Portions of the CFS framing in the vented attic showed signs of tarnishing due to zinc coating corrosion, but all fasteners were free of ferrous oxide (Figure 7.9).

Figure 7.9: Vented attic framing at MCBH Inland after 28 months exposure.

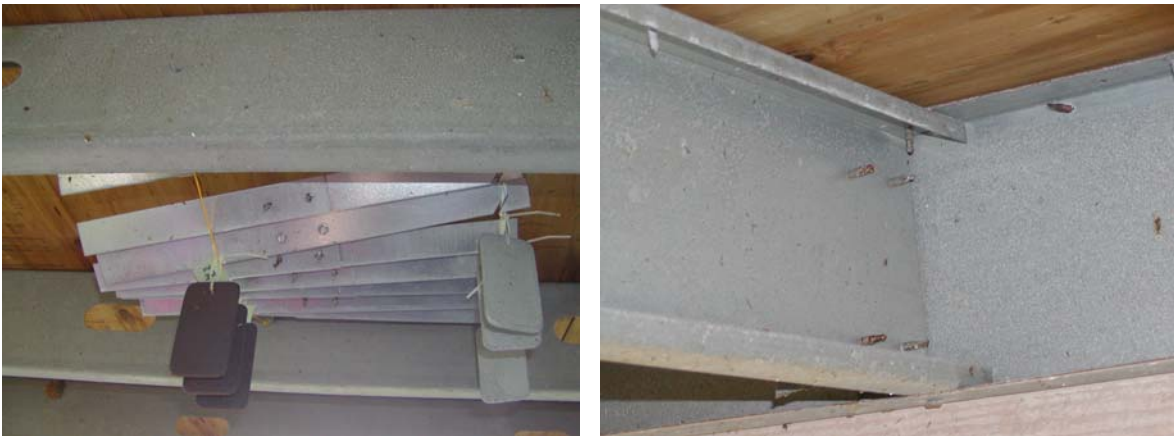
Figure 7.13 and Figure 7.14 show the exposed floor joist framing in the crawl space of the MCBH Inland enclosure. After 16 months, there was some tarnishing of the joists, but no evidence of ferrous oxide on the fasteners. By 28 months, the joists were fully tarnished and minor ferrous oxide was noted on some of the fastener threads. For the floor joists enclosed by plywood sheathing, there were no signs of corrosion after 28 months of exposure (Figure 7.15).

**Figure 7.14: Crawl space floor joists at MCBH Inland after 28 months exposure.**

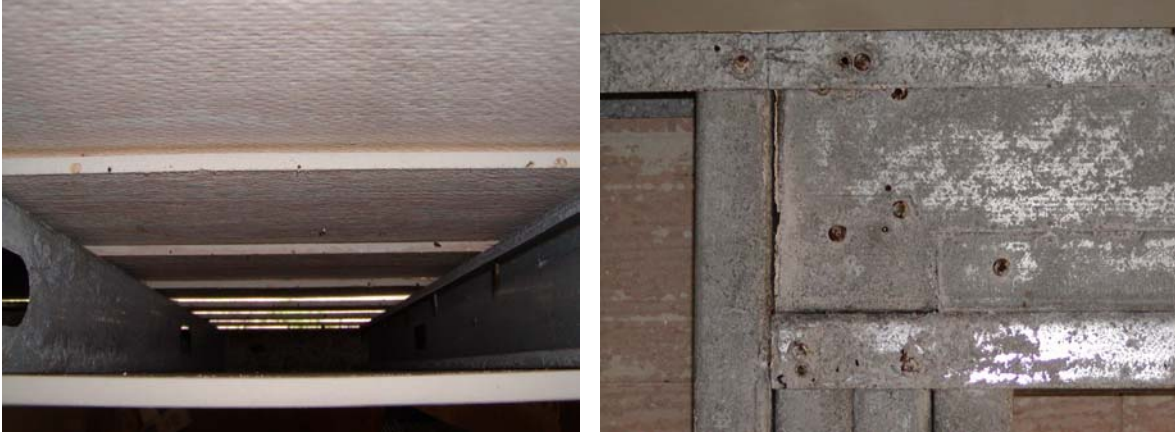
After 16 months of exposure, there was evidence of ferrous oxide on the cut ends of CFS sections and on both heads and threads of the framing fasteners in the wall with lap siding but without a vapor barrier (Figure 7.19). This corrosion was particularly severe at the top plate and top section of the studs, but was evident throughout the height of the studs. This condition worsened after 21 months (Figure 7.20) and 28 months (Figure 7.21). In addition to any exterior air entering through the vented attic to the top of the wall, there was now easy access for exterior air through the lap siding itself (Figure 7.19). The corrosion in this wall was considerably worse than that in either the lap siding wall with vapor barrier or the plywood sheathed wall without vapor barrier.

**Figure 7.19: Wall framing with lap siding without vapor barrier, MCBH Coastal after 16 months.**

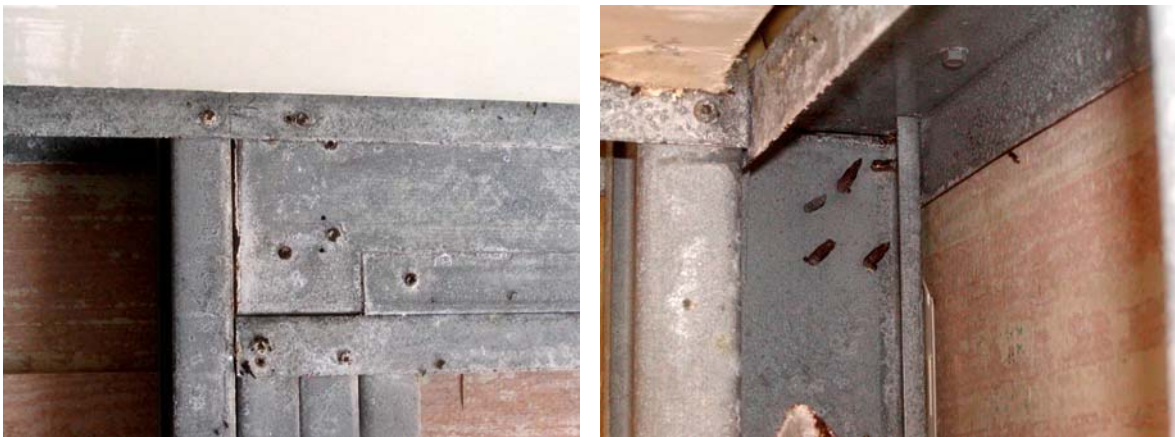
**Figure 7.20: Wall framing with lap siding without vapor barrier, MCBH Coastal after 21 months.**

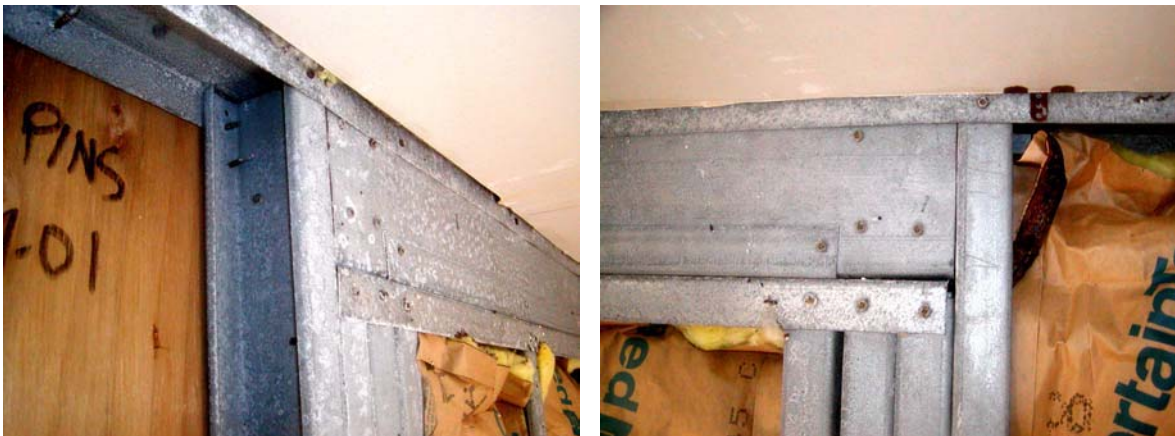
areas of the CFS that were untarnished. There was some progression of the corrosion after 21 months (Figure 7.23) and 28 months (Figure 7.24), including on the ETF pin fasteners used to secure the plywood sheathing, particularly at the top of the wall. In general the observed condition was similar to or better than the wall with lap siding and vapor barrier.

**Figure 7.23: Wall framing with plywood sheathing, MCBH Coastal after 21 months.**

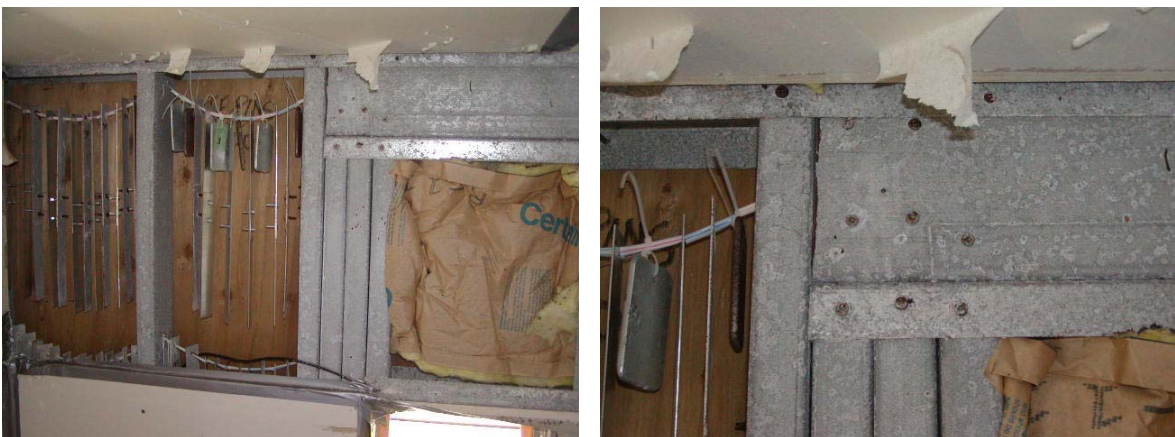
**Figure 7.24: Wall framing with plywood sheathing, MCBH Coastal after 28 months.**

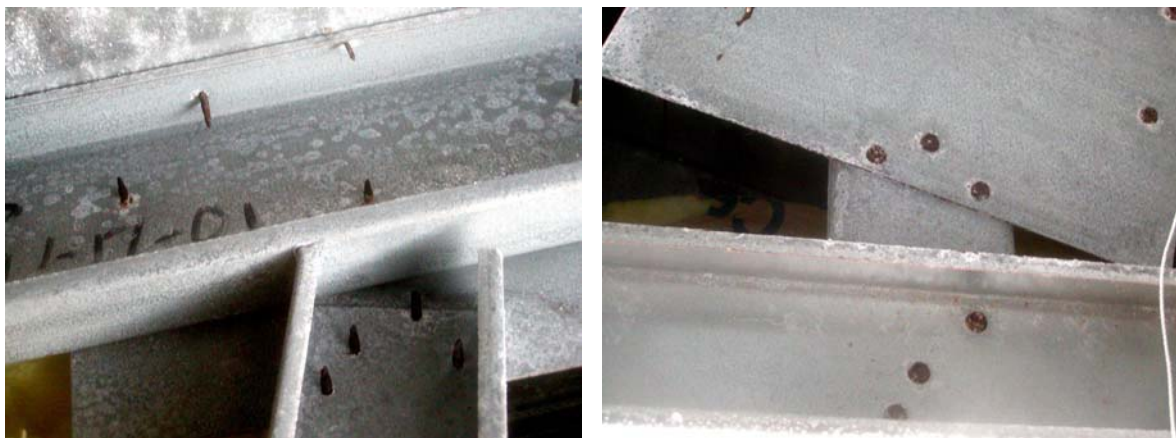
After 16 months there was already significant ferrous oxide on virtually all of the fasteners in the vented attic (Figure 7.25). This condition worsened at 21 months (Figure 7.26) and 28 months (Figure 7.27), by which time there was also significant ferrous oxide at cut ends of the CFS framing members (Figure 7.27).

Figure 7.26: Vented attic framing at MCBH Coastal after 21 months.

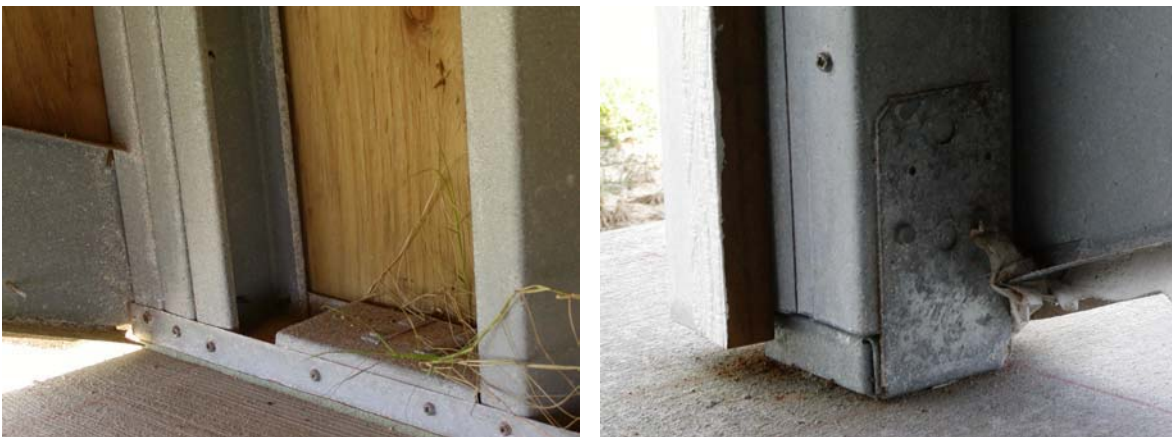
Figure 7.28, Figure 7.29, Figure 7.30 and Figure 7.31 show a progression of the corrosion on the cripple wall and post supports in the crawl space of the MCBH Coastal enclosure. After 5 months there were signs of tarnishing of the zinc galvanizing, and ferrous oxide on some of the fastener heads or threads, and cut ends of the CFS members (Figure 7.28). By 16 months, the zinc coating on portions of the CFS framing had corroded completely and ferrous oxide was forming on end regions of the CFS members and galvanized anchor hardware. There was also significant ferrous oxide on the exposed fastener heads (Figure 7.29). At the 21 month inspection it was clear that this corrosion had progressed rapidly (Figure 7.30) and after 28 months there was clear indication that the corrosion had compromised the integrity of the CFS studs, post and post base hardware (Figure 7.31). The corrosion appeared to concentrate in regions exposed directly to through flow of chloride laden air from the nearby coastline.

**Figure 7.28: Crawl space cripple wall and post, MCBH Coastal after 5 months.**
